ER312B –

203 Goward Road Covenant Property:
Investigating a Changing Successional Trajectory

Submitted by: Steven Burgess

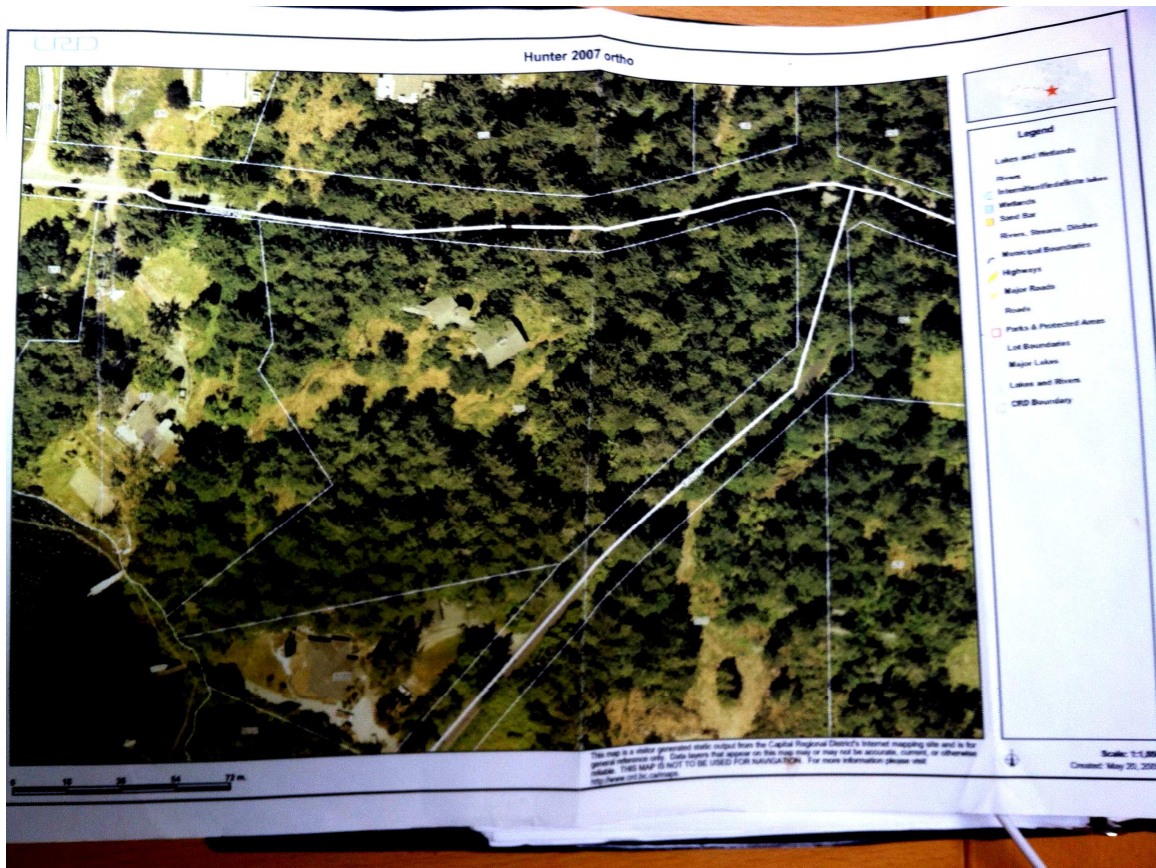
Figure 2 – Aerial map of the 203 Goward property. The dieback zone is in the northwest portion of the property near the corner of Goward Road and Echo Drive. The map is oriented so that north is up.

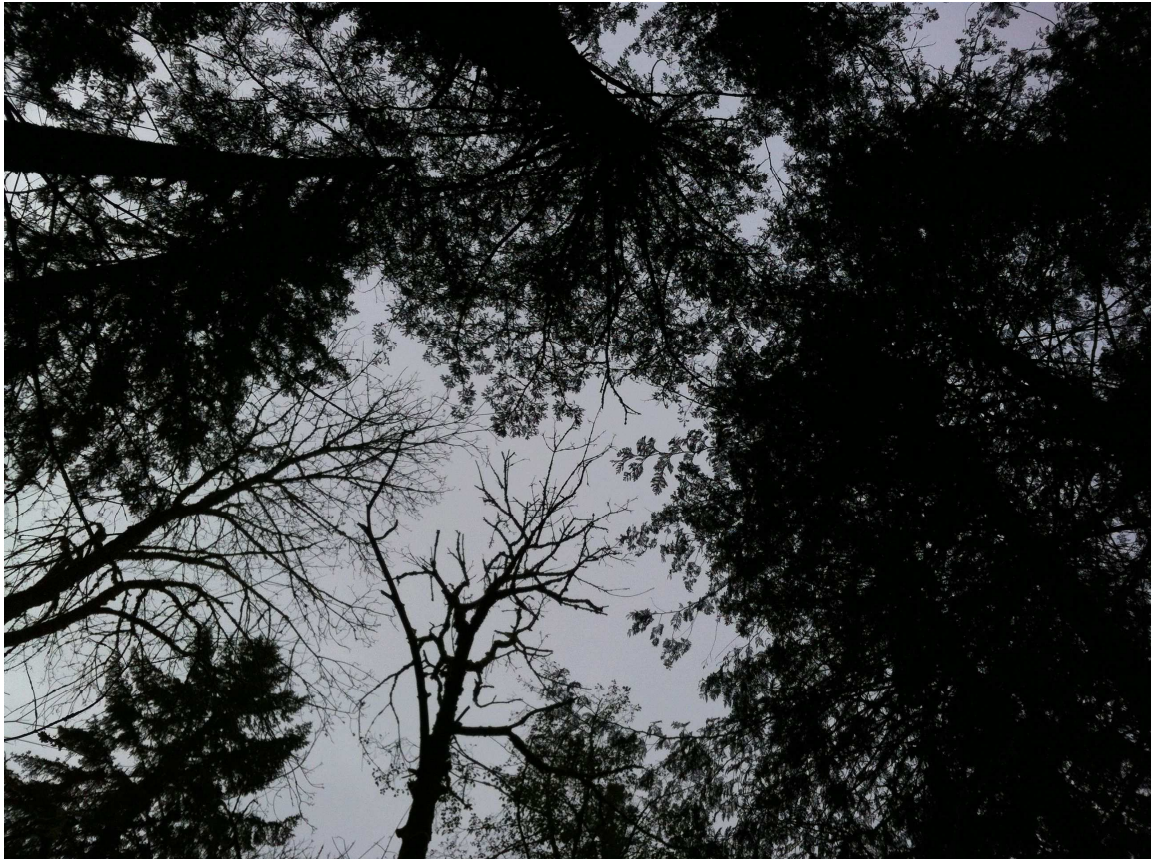
The bulk of the crown dieback is in the Grand fir population of the low elevation zone in the south east of the property. Grand fir is traditionally abundant in dry cool sites with

Figure 4 – Canopy view in the dieback zone

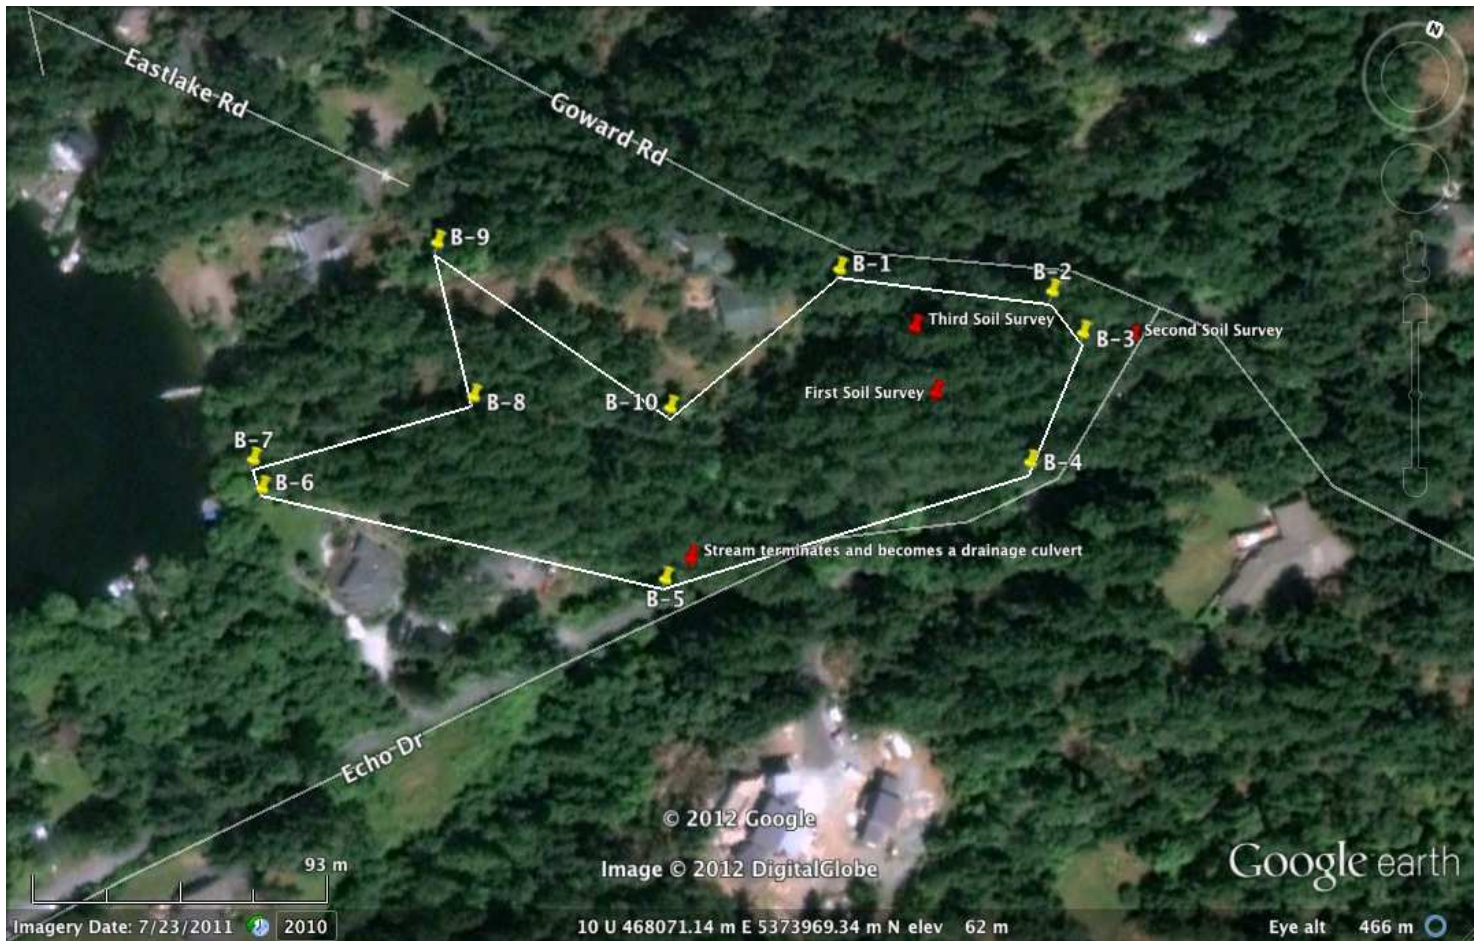
Figure 5 – Boundary of the covenant property and points of interest.

Initial speculation and hypothesizing predicted that the dieback was caused by increase runoff associated with a housing development to the Southeast of Echo Drive. A former baseline report done on the property, conducted by Mogensen et al. 2006 (Figure 1), included a riparian area in the northwest of the property that they concluded originated from a spring slightly uphill. Upon inspection of the property it became apparent that there was indeed running water present and it coincided neatly with the dieback zone. However, the origin of the stream cannot be confirmed as the spring. Runoff channels leading off to the newly added driveway would agree with the adjacent development theory; however, free flowing water is apparent in abundance farther upstream of the property. Therefore, the inundated soil cannot be blamed

Two possible courses of action have been determined from this study. First, an invasive plant removal plan of this area is suggested as a precursor to any other remediation work (please see Teren Sunstrum's report). If retention of the Grand firs that are desired, then the digging of a trench to divert the water draining through the culvert is suggested. This can follow the property line and connect with another already existing culvert paralleling Echo Road

further downhill (Figure 5). This could intercept some of the water that runs off the new development and hopefully reduce water in the dieback zone back to a manageable amount for the soil to process. The only issue with this is that there is no guarantee that this will reduce the moisture level below soil saturation. Small increases in impermeable surface greatly influence runoff levels and percolation ability (Schafer, 2004 & Newbound et al., 2010). Furthermore, if it did work it may only be a temporary solution, as further development in the subdivision would only lead to this problem reoccurring in the future.

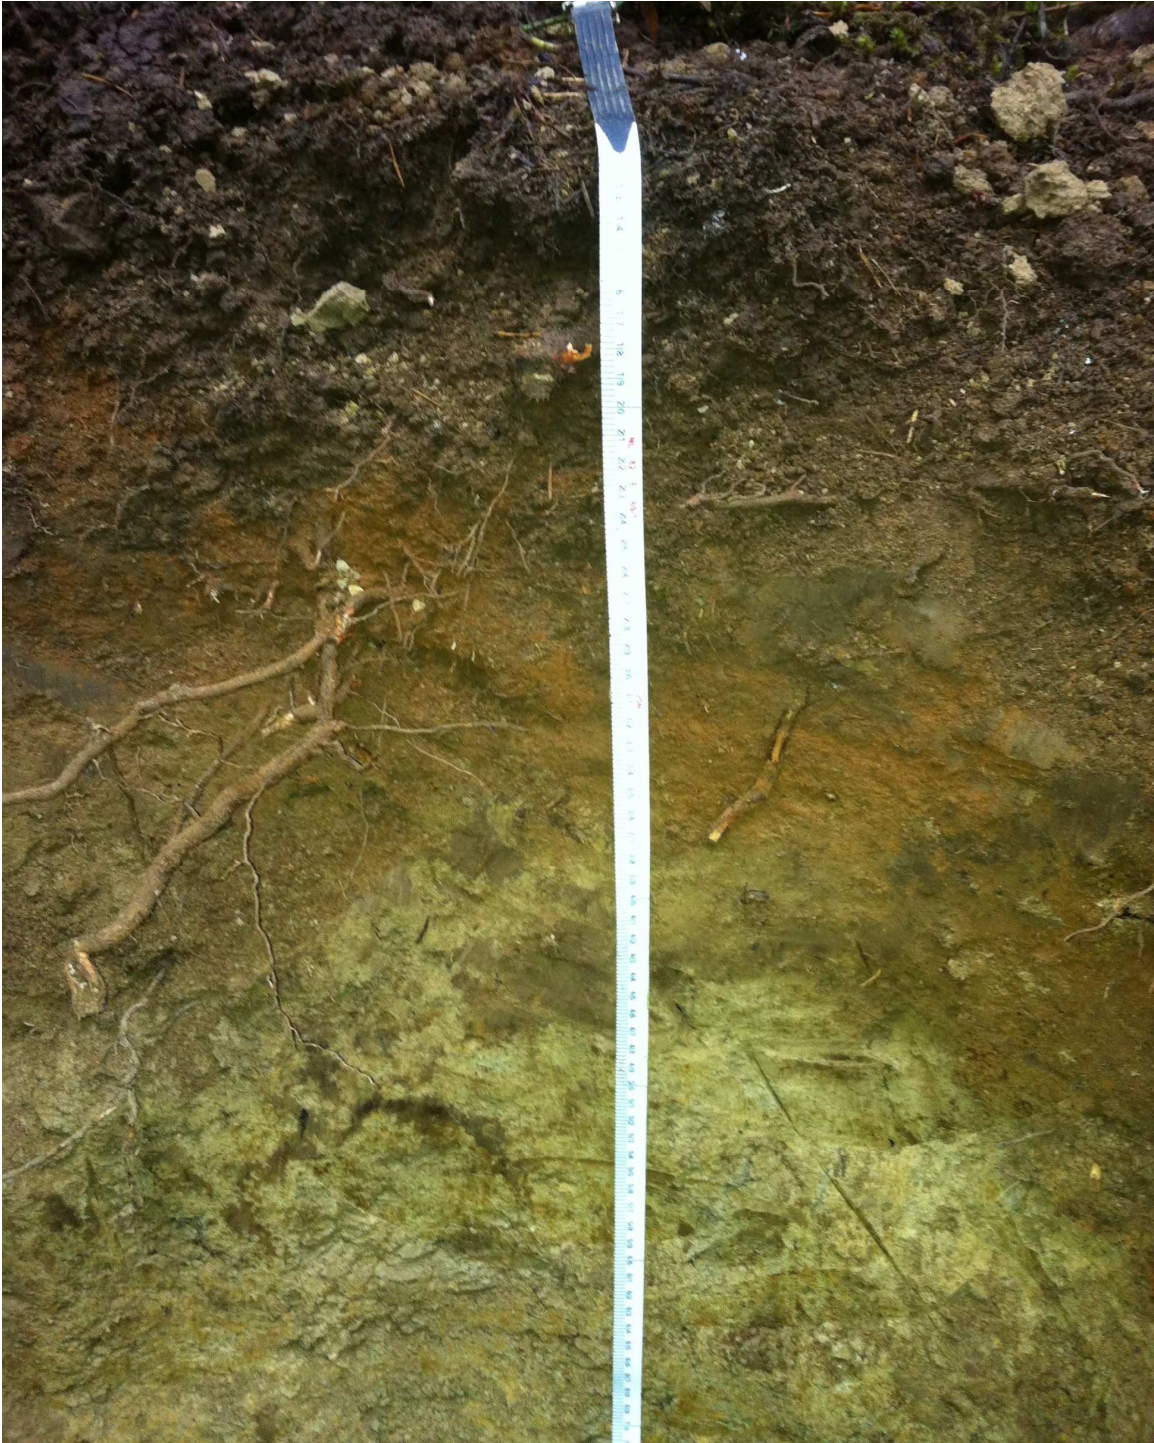
The first soil pit dug in the dieback zone proved to be stereotypical of the Saanichton soil series. The Ah layer was a clayey silt loam and about 25cms thick. At about 45cm the B horizon starts as a thick heavy clay layer. It was difficult to break up and came up in thick aggregates. There was no coarse material found in this area at all. The high clay content

suggests that drainage is quite poor. The soil was fairly wet and suggested that the trajectory of this soil type is the CwBg – foamflower. The dominant species in this soil type are Western Red Cedar (*Thuja plicata*), Douglas fir (*Pseudotsuga menziesii*), Big Leaf Maple (*Acer macrophyllum*), and Grand fir with dull Oregon-grape (*Mahonia nervosa*) and sword fern (*Polystichum munitum*) as the dominant understory species, all of which are abundant on the property uphill from the site.

Figure 6 – The profile of the first soil pit just outside the waterlogged section of the dieback zone.

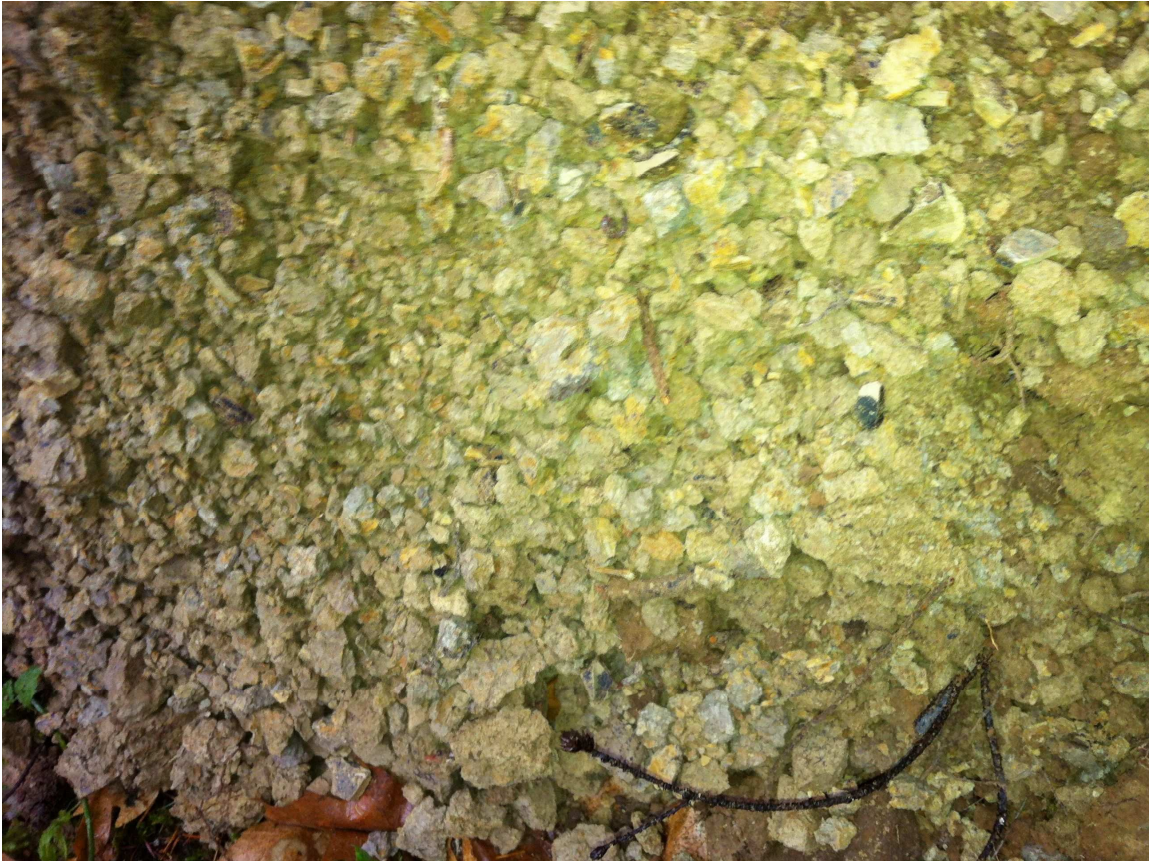
The second soil pit at the top of the stream was quite illuminating. Upon initial inspection it became apparent to the team that there was a culvert allowing the water to run from the property located uphill from the covenanted land. Furthermore, just above the culvert was a fire hydrant indicating that municipal water mains run underground in the area as well. The area selected for digging was quite loose and gravelly at its surface. Once digging commenced it became apparent that this gravelly material was eroded content. There was 15cm of eroded material above the original humic layer. The Ah horizon again was textured and also proved to be a clayey loam, potentially at least 50% clay. There were few if any naturally occurring coarse fragments, aside from some unidentified glass material that was most likely discarded human artifacts. At 50 cm deep (35cm not including the upper eroded layer) the water table was hit, at the beginning of the B horizon. Thus proving that there is an additional source of groundwater adding to the accumulation at the dieback area.

Figure 7 – The gravelly eroded material found above the organic layer in the second survey site

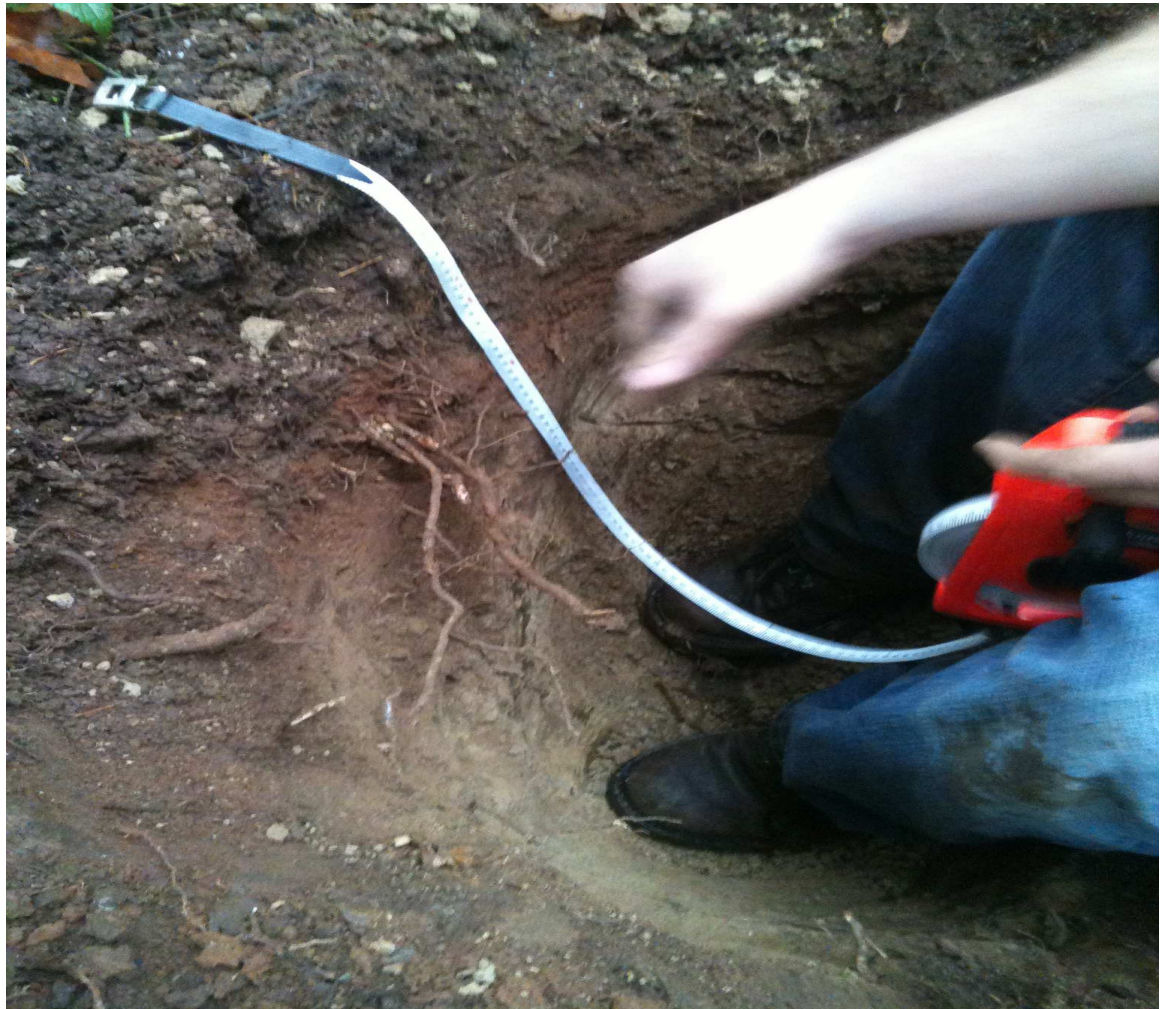
The third and final soil analysis was preformed in a nearby Grand fir community. The soil survey here was quite helpful as it painted a very different picture than the first soil pit. First off, the humic layer was roughly 5cm thicker than that of the of the dieback zone. This is most likely due to the decreased erosion and leaching rate caused by the inundated soil and the free moving water in the dieback zone. The humic layer was also very rich in mycelium, far greater than either of the other two soil survey sites. The Ah horizon was still a loam but with a far greater sand content. The B horizon had an even greater sand content with little to no clay. Furthermore, there was about a 30% coarse fragment content with the majority being stones or cobbles. As expected being slightly uphill from the stream and with a far better drainage potential the site was rich and fairly dry and seemed to represent the Sprucebark site series. As mentioned before Grand fir thrives in rich dry to rich moist soils and does poorly in very wet

conditions. Therefore, it seems intuitive that the Grand fir population located at this point is doing quite well.

Figure 8 – Analyzing the third soil pit. Majority sand with a high amount of mycelium in the organic layer

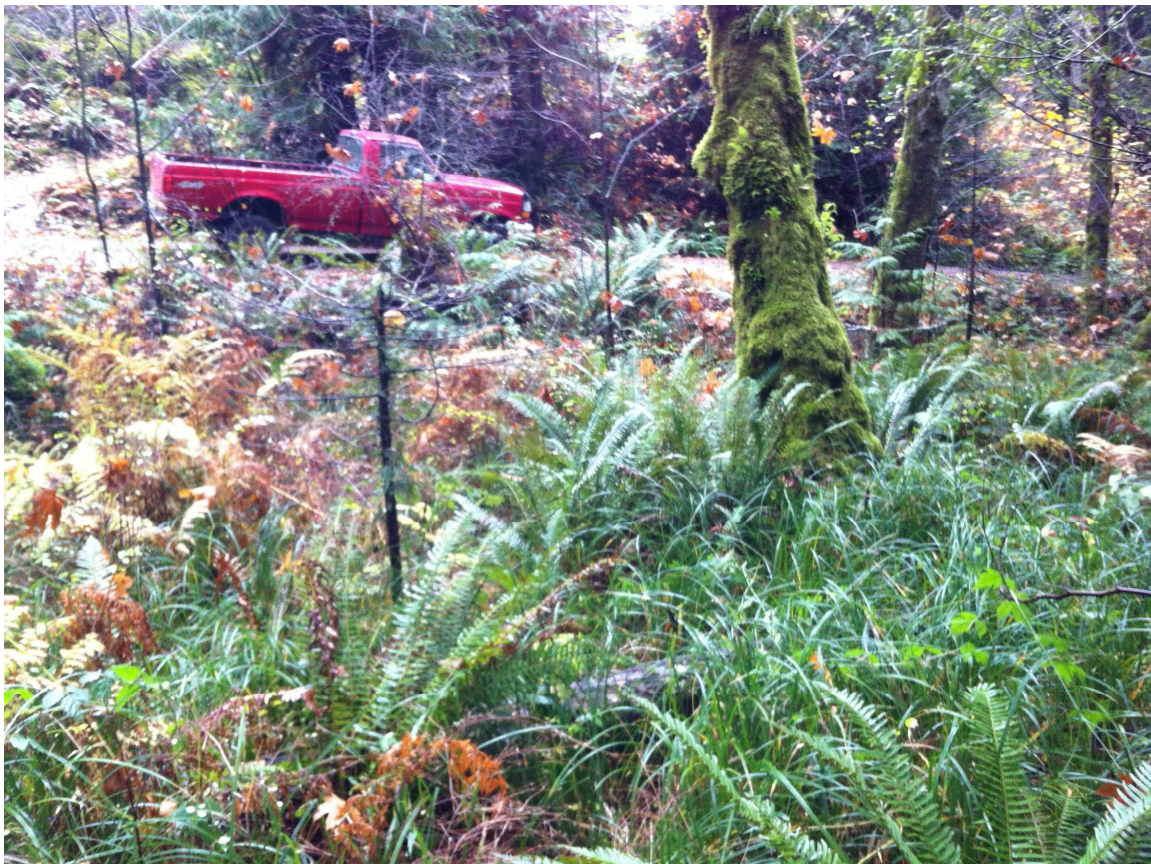
Figure 9 – Hydrophilic vegetation in the dieback zone. The development's drive way is in the top left of the picture with a workers truck parked on the curb.

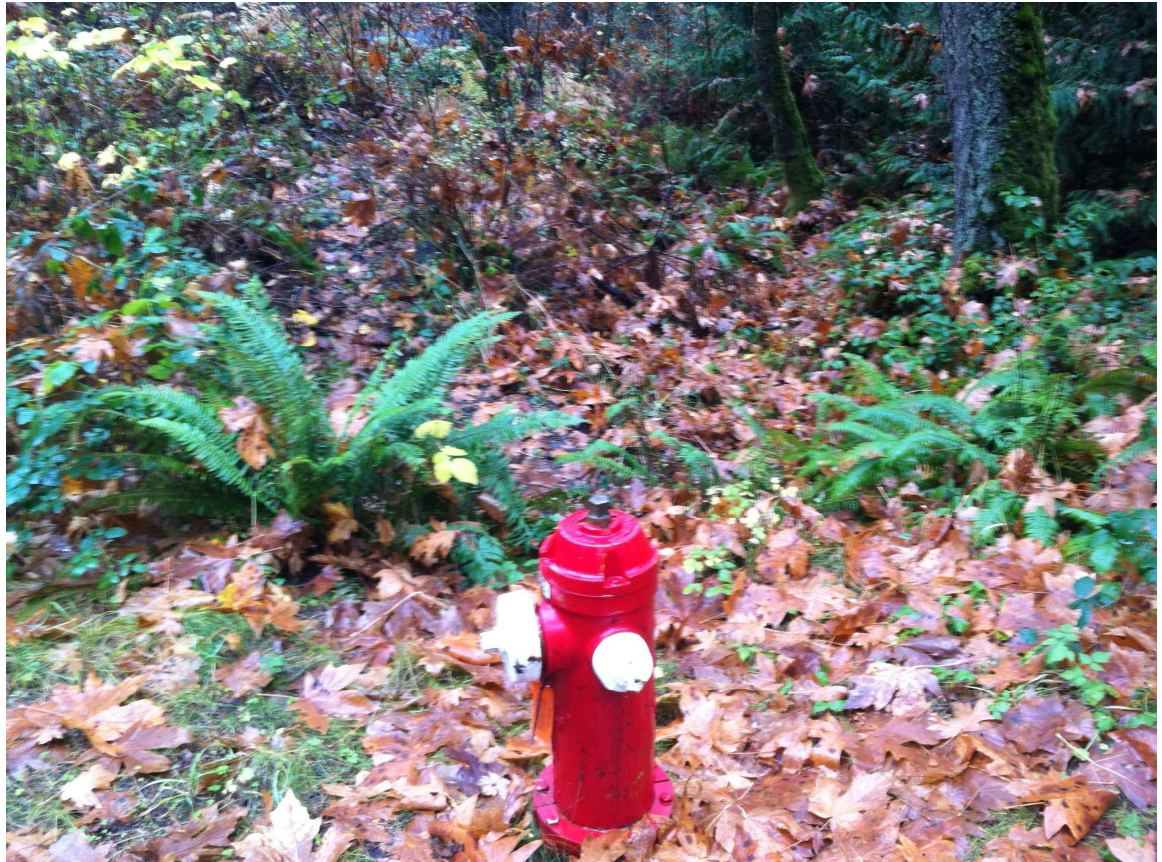
Figure 10– The fire hydrant at the mouth of the culvert. The free water can be seen heading down the property.

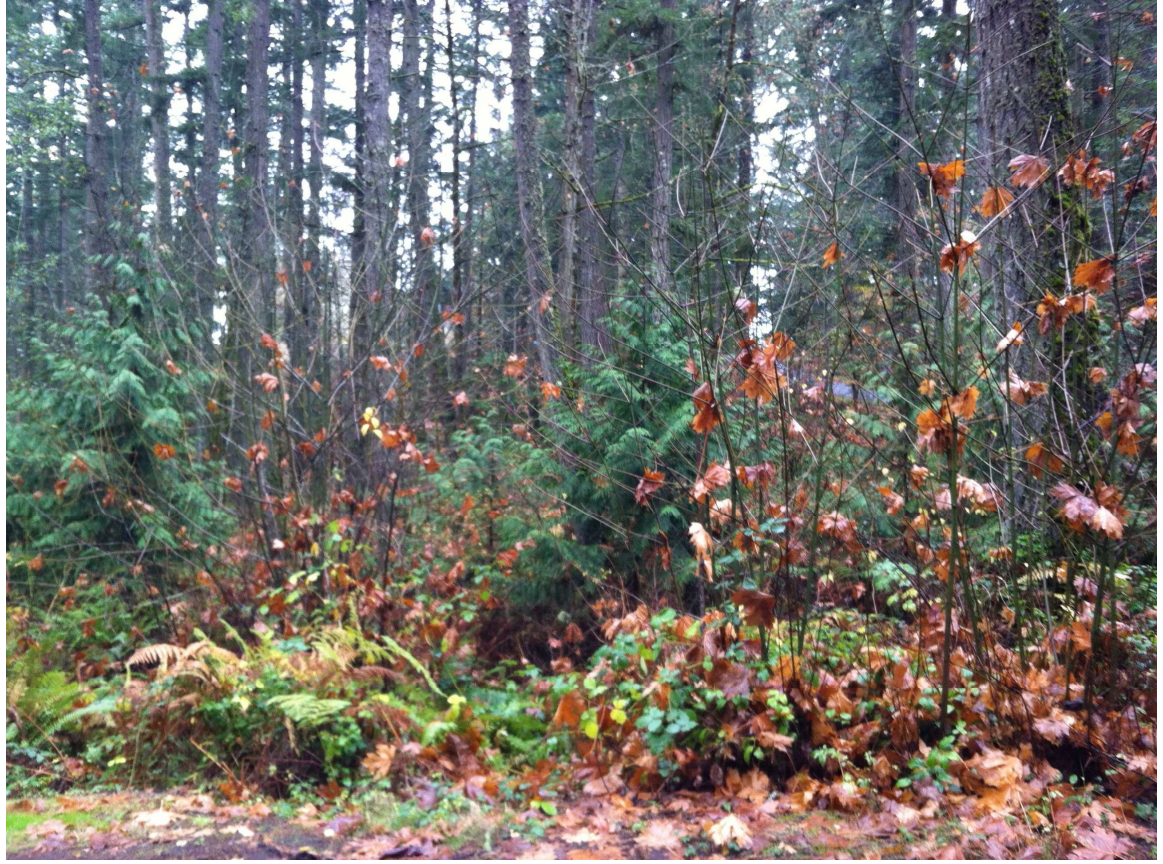
Figure 11_– Thriving Western Red Cedar and Big leaf Maple saplings dominate the understory in the riparian zone.

The second option would be to embrace the increased water level and aid the community in its transition. This would entail protecting the young Western Red Cedar saplings as browsing is exceptionally high in this species in thinned stands (Mass-Hebner et al., 2005). Further on if the condition of the Grand fir does not improve then eventually topping for use as wildlife trees may be required. Native hydrophilic vegetation can be planted, such as skunk cabbage. As the novel community develops and the saturation of the soil decreases, dormant mycelium spores should develop and aid young Western Red Cedar and Big Leaf Maple. The opinion of this study is to assist the natural transition process as continuing development in the community is imminent.
