Tod Creek Flats

Integrated Management Plan

The Corporation of the District of Saanich
and The Friends of Tod Creek Watershed

November 2009

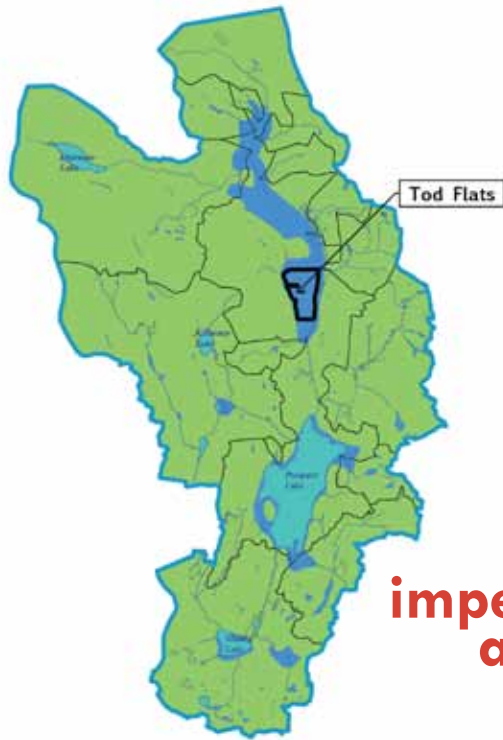
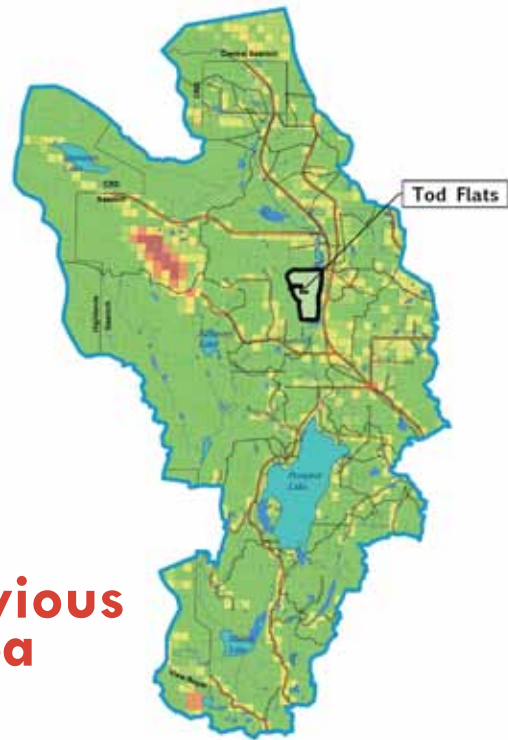
**impervious
area**

This study did not measure impervious surfaces but impervious cover data from the CRD (Natural Areas Atlas mapping, 2009) does show impervious areas (roads and buildings). Given the nature of urban development, most runoff from the roads is conveyed by ditches to the nearest stream. Although damaging, urban development remains scattered throughout the watershed and tends to be large lot, rural hobby farms with relatively low density and low effective impact area. These tend to have simple drainage systems that often spill onto the land rather than be connected to large piped infrastructure systems. In simple terms they, are disconnected from the downstream receiving waters and therefore do not contribute much in the way of stormwater to the system. Hydrological

impacts are typically noted when effective impervious area is greater than 10% in a watershed or sub-basin area. That level has not been reached in the Tod Creek watershed. From a development perspective, care should be taken with regard to future development within the non-basin drainage areas that contribute to the flats along with the Ward and Wray sub-basins areas that feed the stream adjacent to the flats. Low Impact Development (LID) planning and design practices should be applied in these areas and elsewhere in the watershed. Drainage practices that disconnect impervious areas from streams and ditches should be encouraged.

- some increase mostly due to roads and buildings
- not a significant impact to Tod Flats hydrology
