**Tod Creek Golden Willow Removal Project - Whitehead Park, Saanich, BC  
September 2010**

Prepared by:  
TerraWest Environmental Inc.

Project File: DSWP10-01

10 November 2010

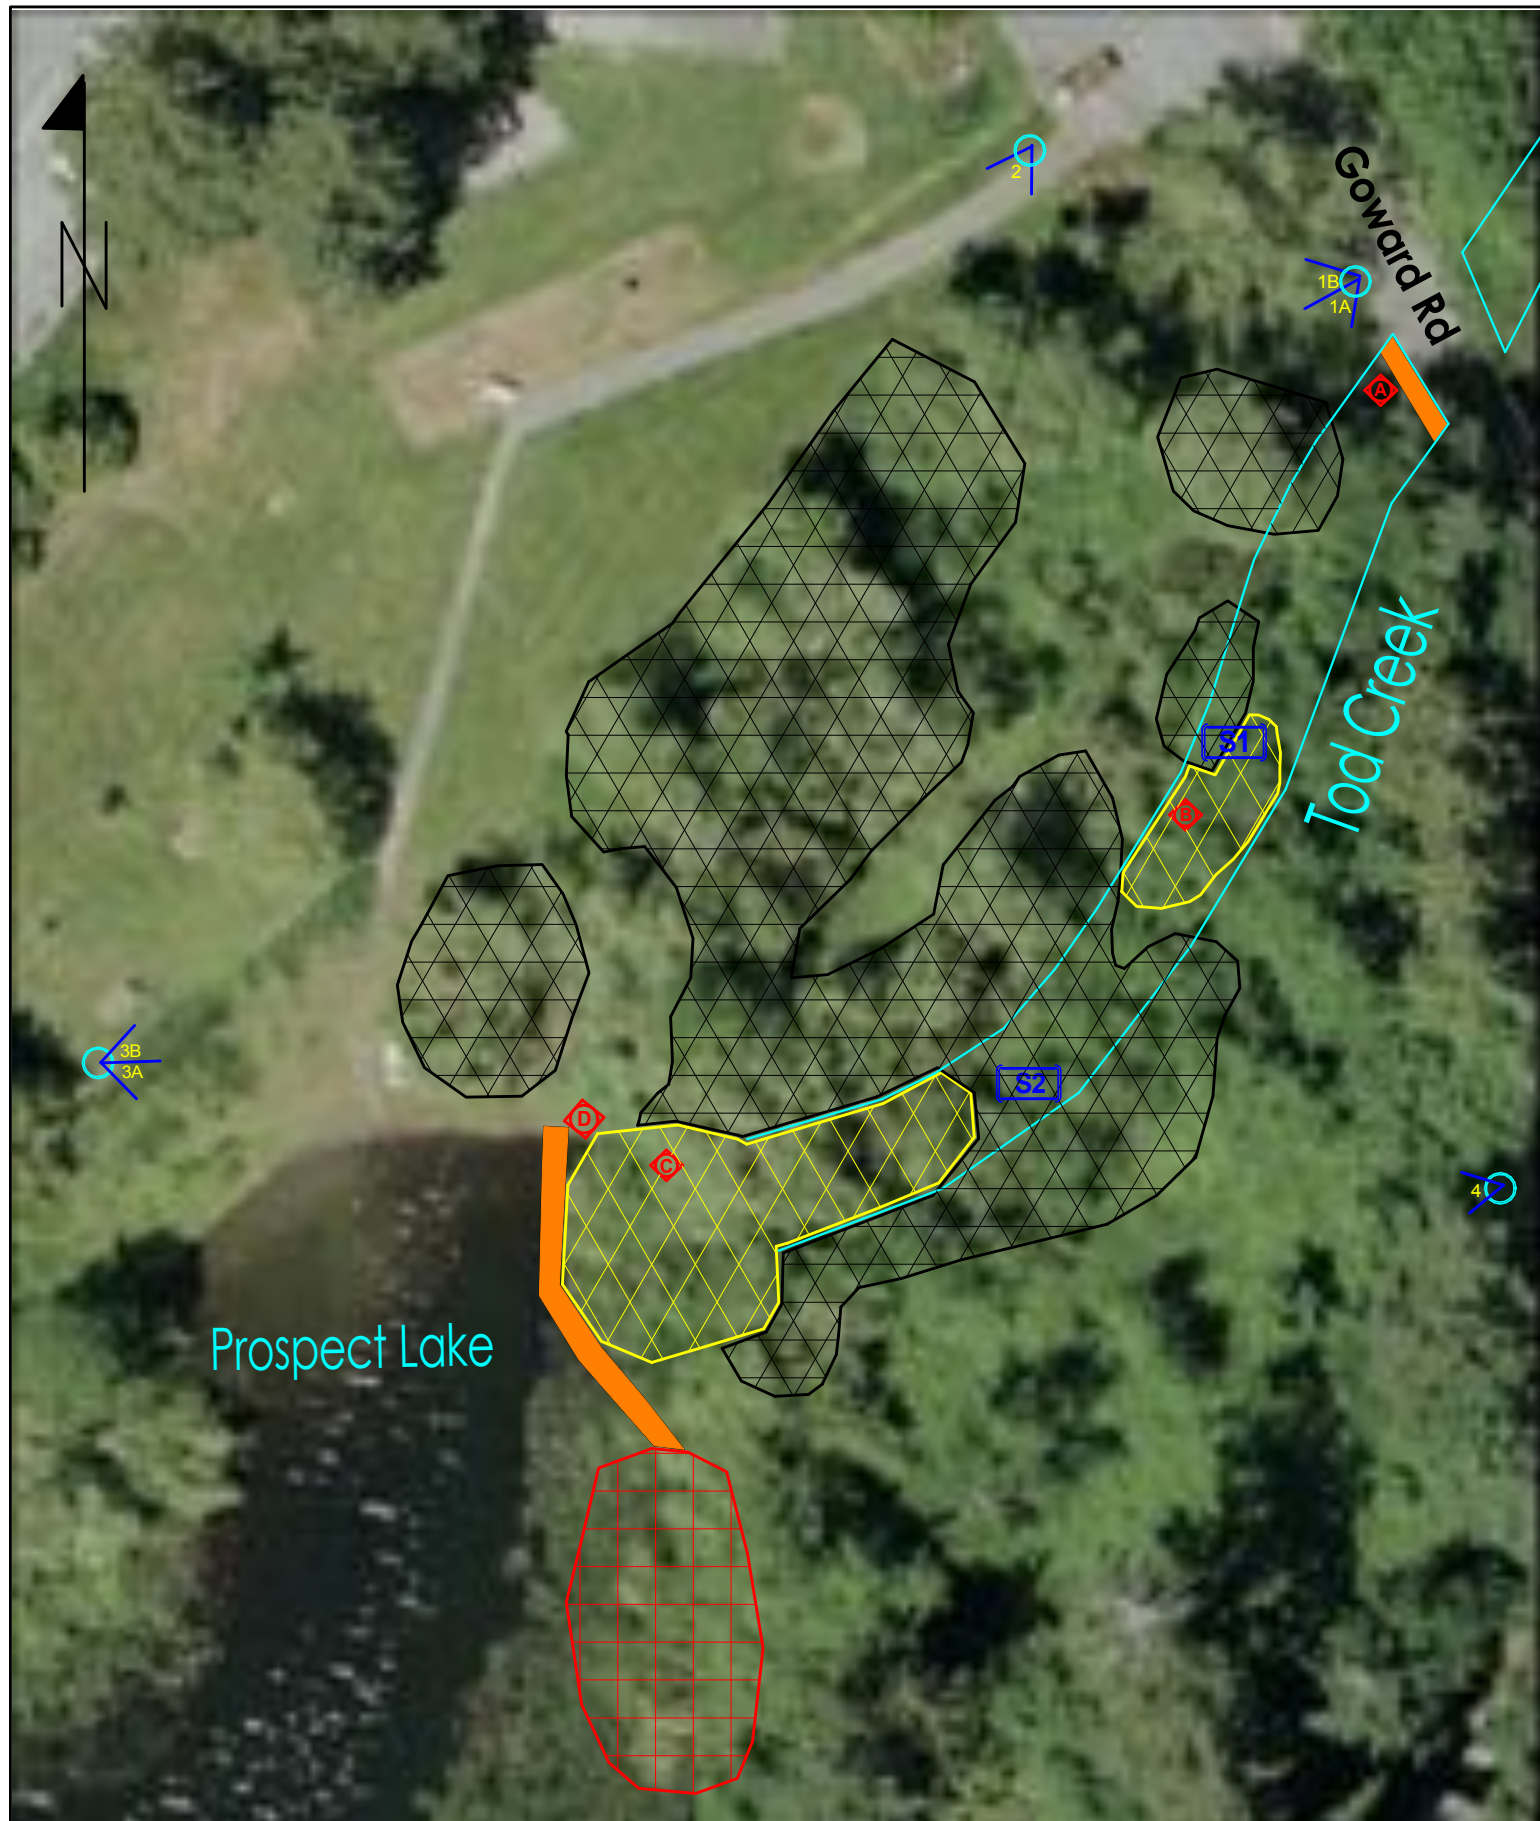
Tod Creek Golden Willow Removal Project - Whitehead Park, Saanich BC September 2010

Water quality and fish presence at the site are greatly diminished by extremely thick and unconsolidated organic sediment, in many places 1 – 3 m (4 – 10 ft) deep. Two sediment depth monitoring stations have been established along the creek and should be periodically measured (at least twice annually) to record the rehabilitation of the stream bed as accumulated sediment decays or is mobilized during strong flows. The two monitoring stations are shown in Figure 1 and in Photos 25 and 26.

Flow Control System  
 Photo Monitoring Stations  
 Water Quality  
 Assessment Stations  
 Sediment Monitoring Stations

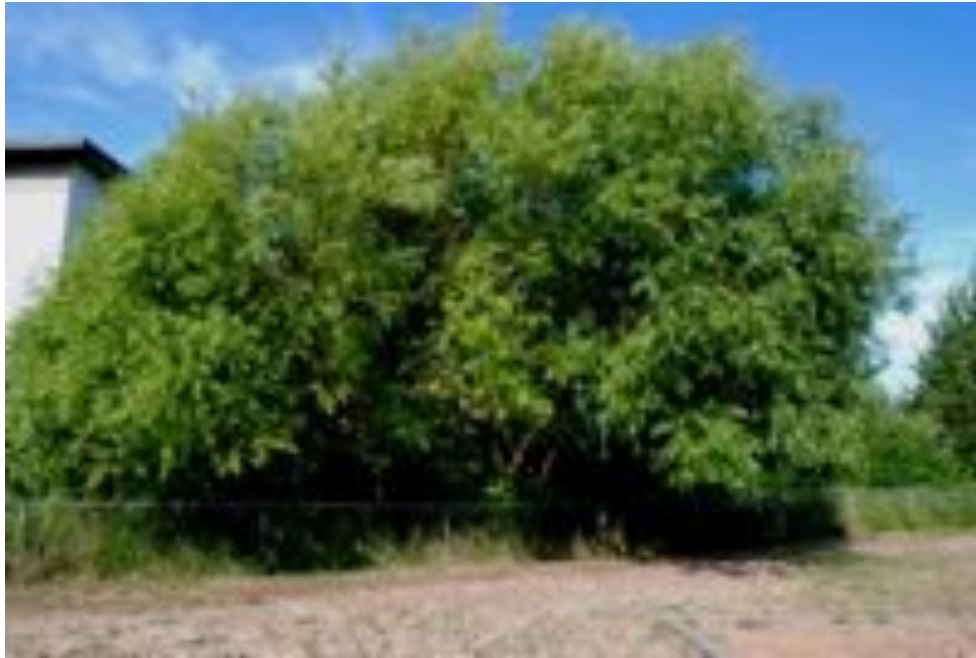
GOLDEN WILLOW HAS COLONIZED THE CHANNEL OF BOWKER CREEK IN THE AREA OF ST. PATRICK'S SCHOOL.

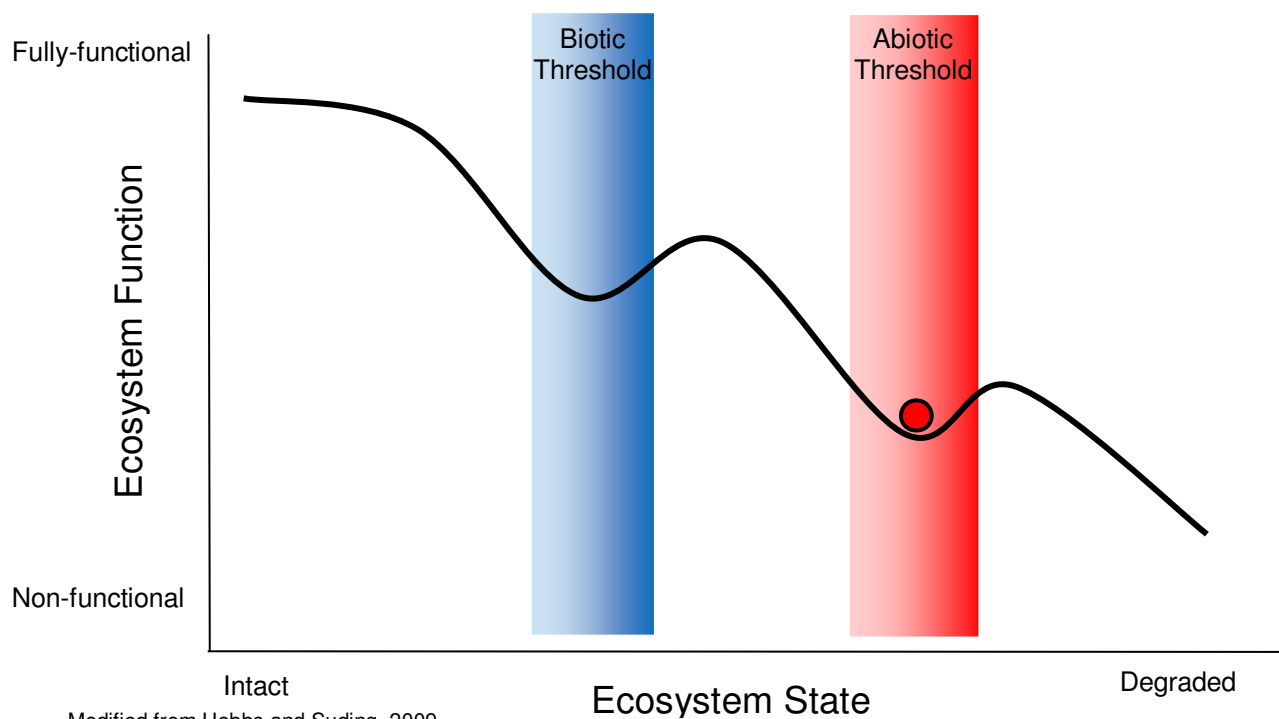
The first step in defining restoration strategies is to determine what is causing the degradation. Figure 1 provides a conceptual framework for looking at degraded landscapes. Ecosystems such as Bowker Creek can go from a fully functional state (intact) through thresholds (biotic and abiotic) to a non-functional state or degraded condition. Bowker Creek is currently in this degraded, non-functional state represented by the red ball. The pockets in the ecosystem state line at these thresholds are suggestive of the energy that might be needed to move the ecosystem out of this degraded state.

**Figure 1.** Changes in ecosystem state as a result of crossing biotic and abiotic thresholds cause changes in ecosystem functions.

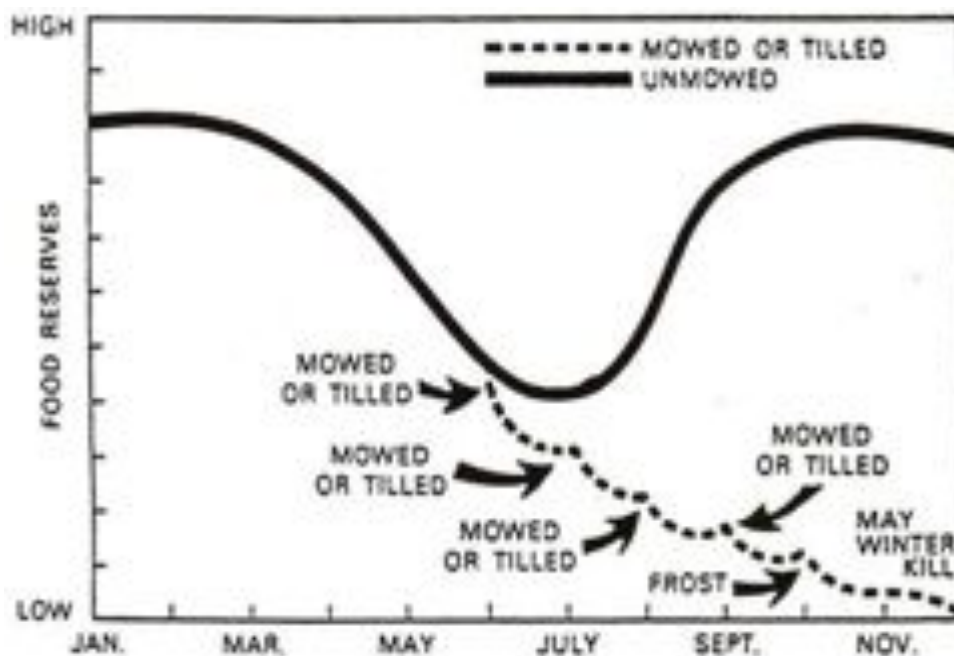
killing it. Figure 2 shows a graph of plant energy (food) reserves through the seasons and the effects of repeated cutting.

**Figure 2.** Generalized graph of plant energy reserves follows a seasonal sine wave pattern. If plants are cut or otherwise disturbed repeatedly, then they will eventually die.

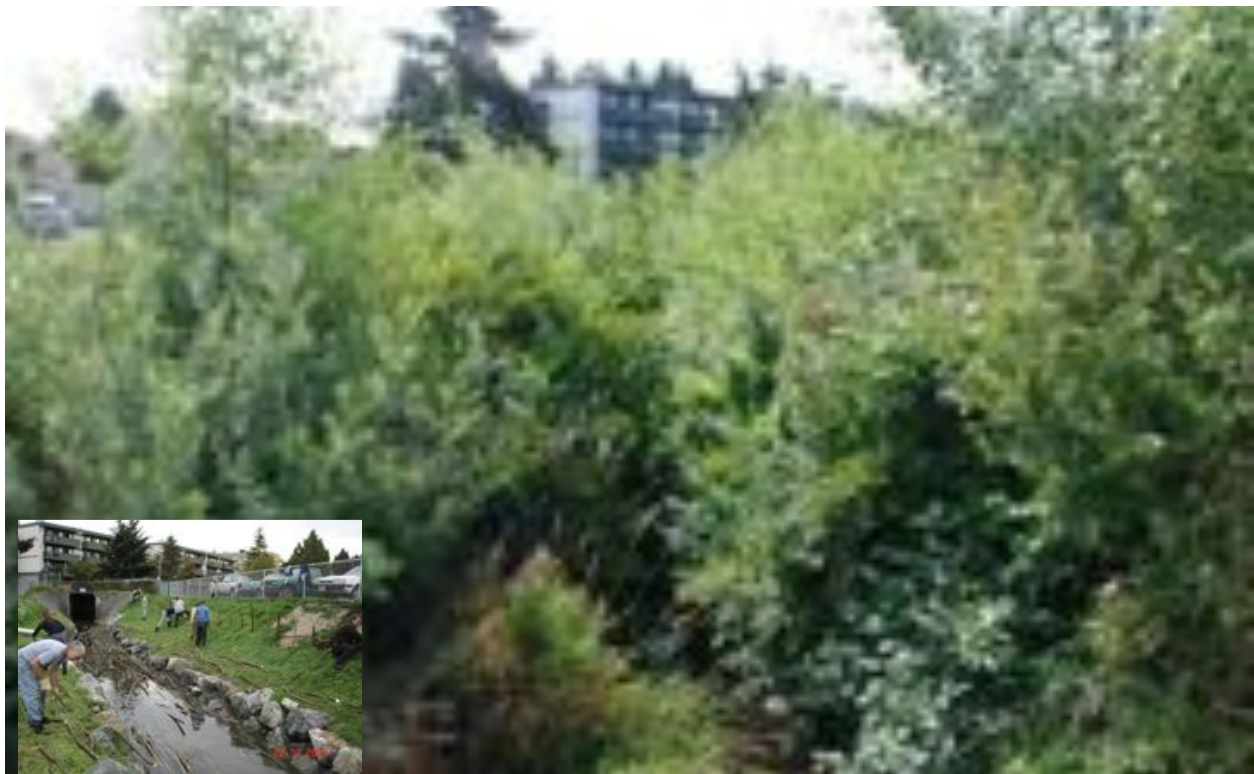
**Photograph 1.** Excellent growth of native riparian species downstream of the bridge at St. Patrick's School provides significant riparian benefits. The small photograph inset here shows this site at the time of treatment. Only the top of the apartment building in the background can now be seen.

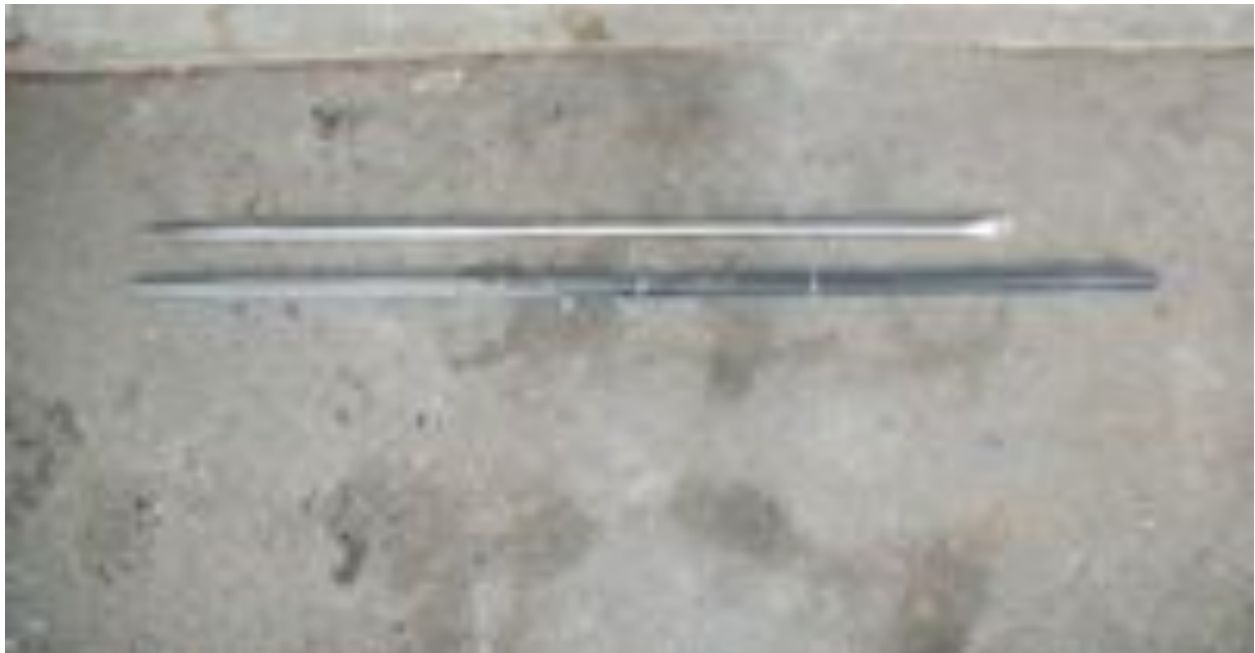
Planting cuttings is simply a matter of sticking the cutting into the ground to the required depth. The problems arise when the ground is too stiff to be able to insert the cutting. Sharp pointed bars (Photograph 2) can be used to create holes into which the cuttings can be tapped. By using long cuttings (2 m) the water slowing effects that were provided by the golden willow can be replaced with the beneficial plants. The retention of the root systems of the golden willow will allow the replacement plants to be established over several seasons if needed. However, some cuttings establishment following the initial removal of the golden willow is recommended as the loss of this volume of biomass may have a significant impact on the hydrology of Bowker Creek.

**Photograph 2.** These two planting bars have proven to be effective. The larger bar is about 1.5 m long and weighs about 10 kg. The marks on the large bar indicate 50 cm, 75 cm and 1 m from the tip of the pointed end to allow the depth of holes to be gauged.

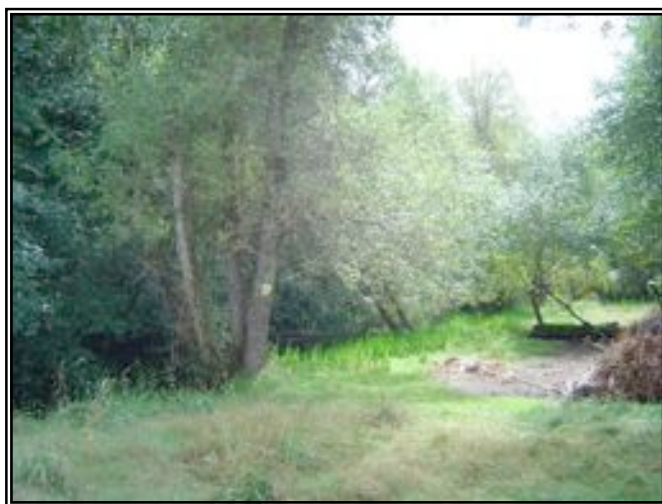
**1. Photopoint 1a:** 27 Aug 2010 – Prior to clearing

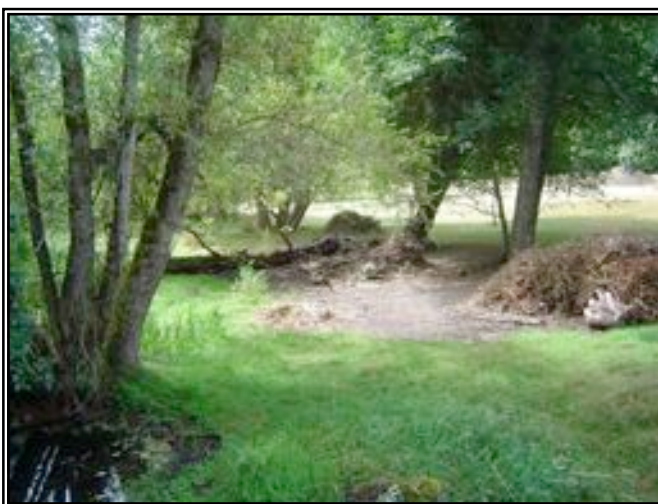
**2. Photopoint 1b:** 27 Aug – Prior to clearing

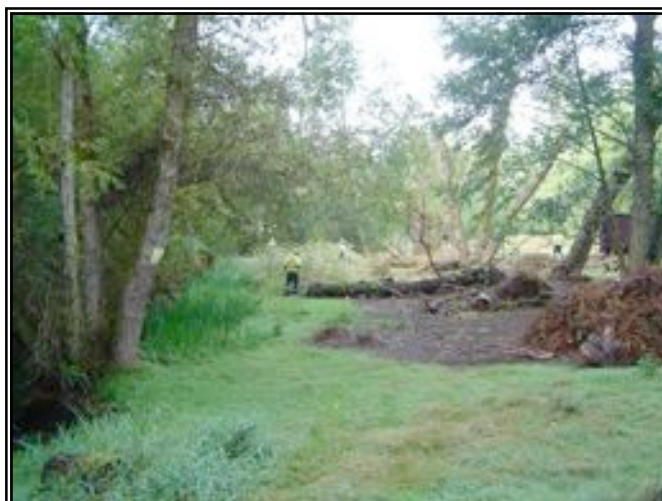
**3. Photopoint 1a:** 9 Sept – Major tree felling

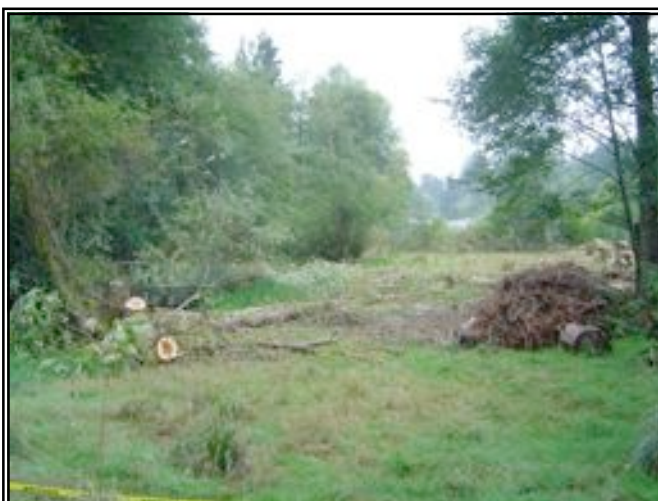
**4. Photopoint 1b:** 9 Sept – Major tree felling

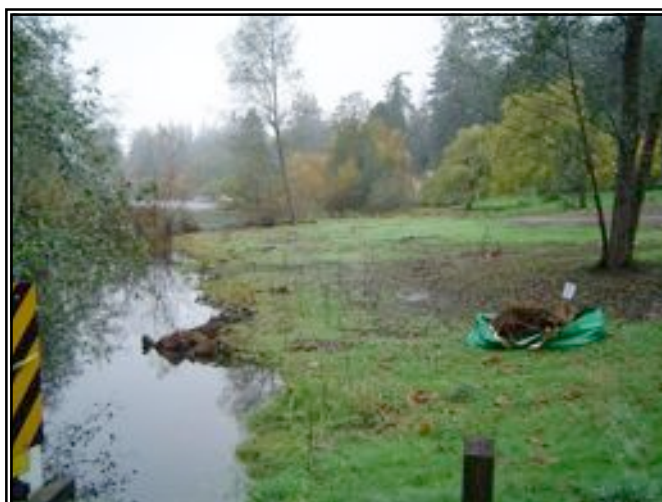
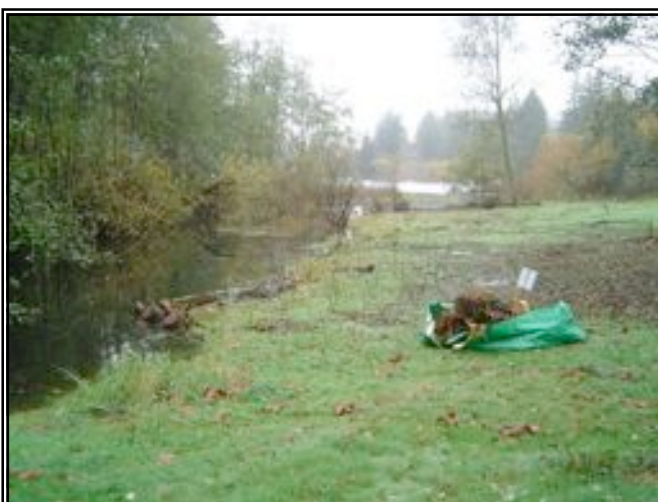
**5. & 6. Photopoints 1a & b:** 2 Nov – Site completion with start of native cuttings planting

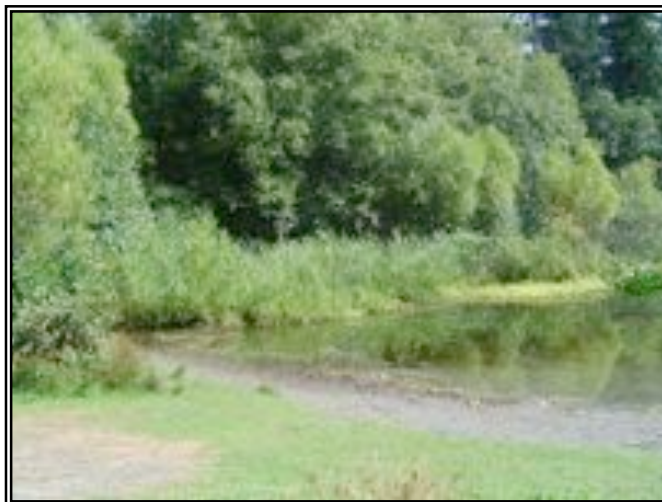
**7. Photopoint 3a: 27 Aug – Prior to clearing**

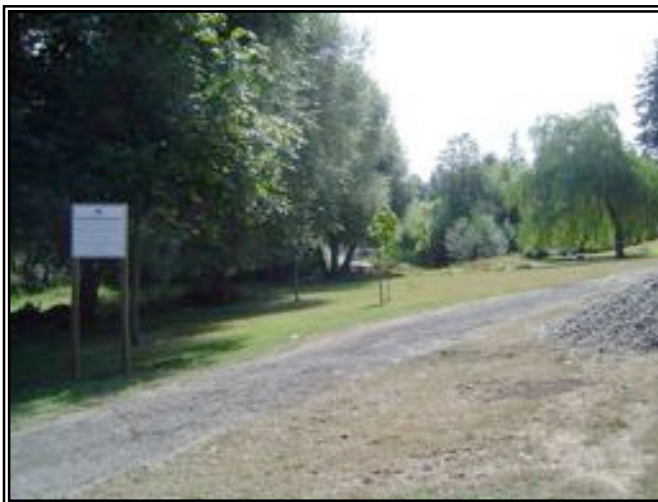
**8. Photopoint 2: 27 Aug – Prior to clearing**

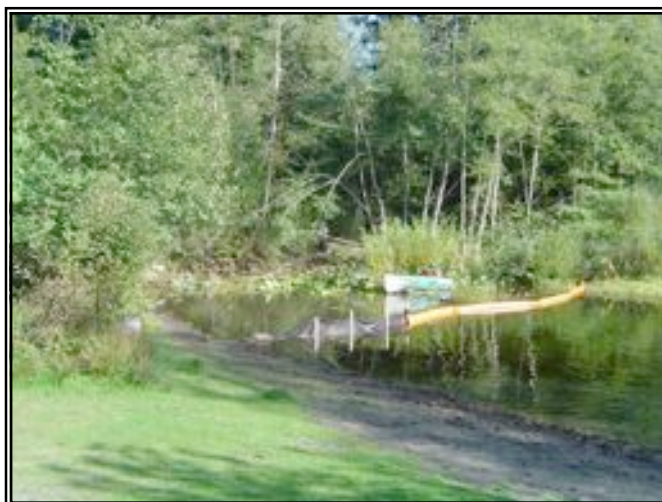
**9. Photopoint 3a: 22 Sept – In-stream willow removal**

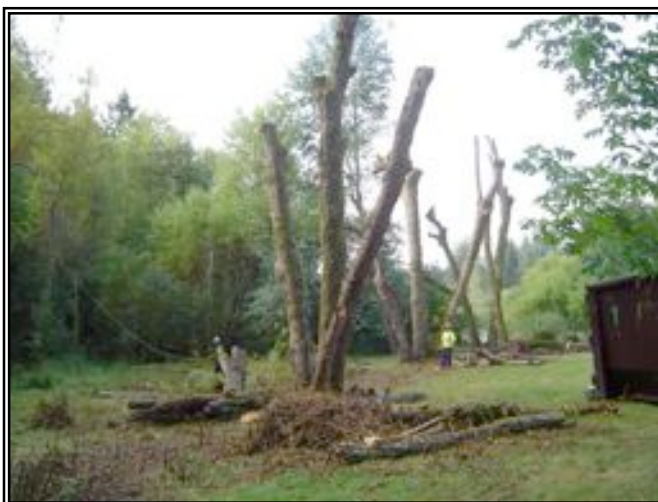
**10. 9 Sept – Major tree felling**

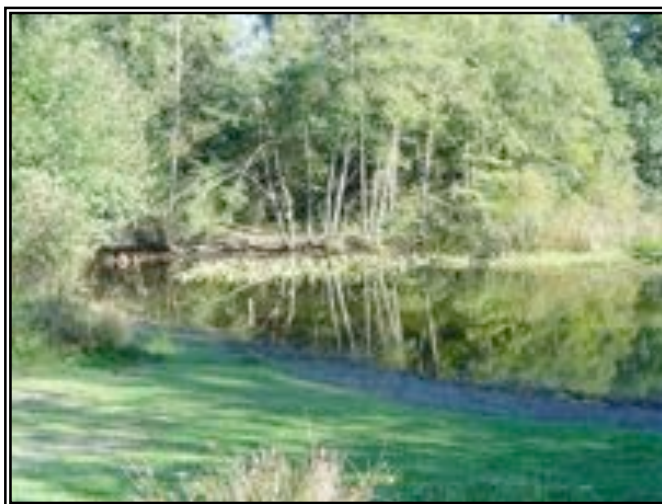
**11. Photopoint 3a: 5 Oct – Site completion**

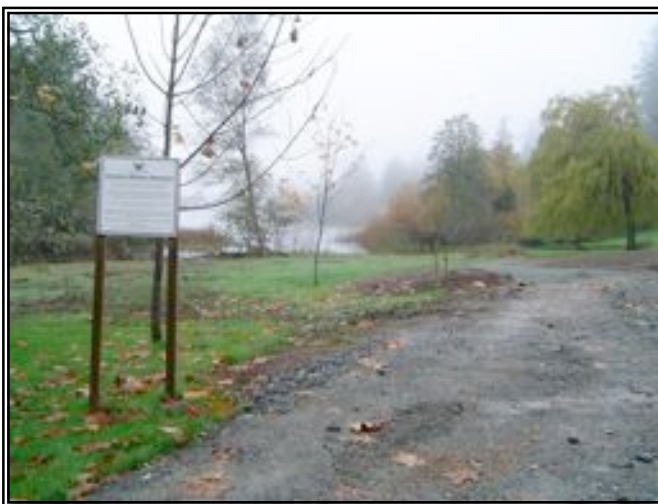
**12. Photopoint 2: 2 Nov – 1 month post-completion**

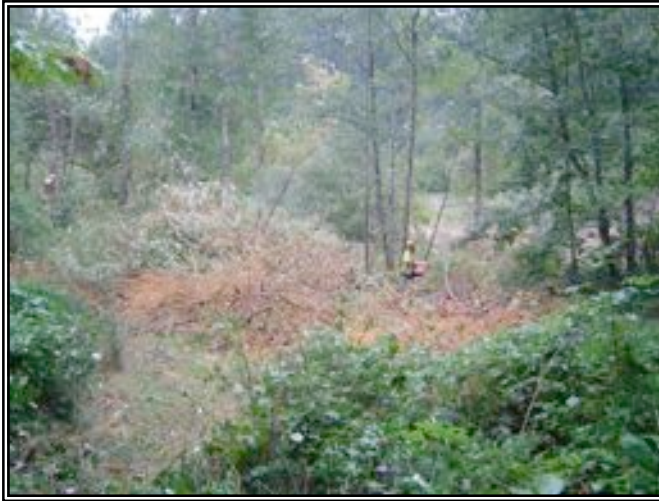
**13.** Photopoint 4: 15 Sept – East bank during clearing

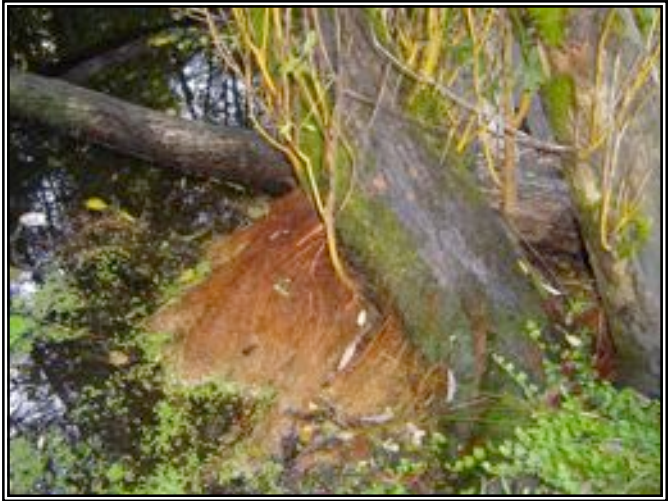
**14.** Golden willow root mats and suckers

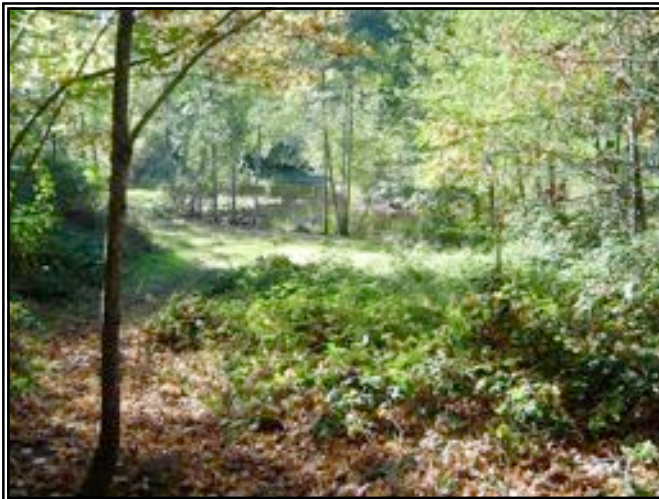
**15.** Photopoint 4: 29 Sept – Eastbank site completion

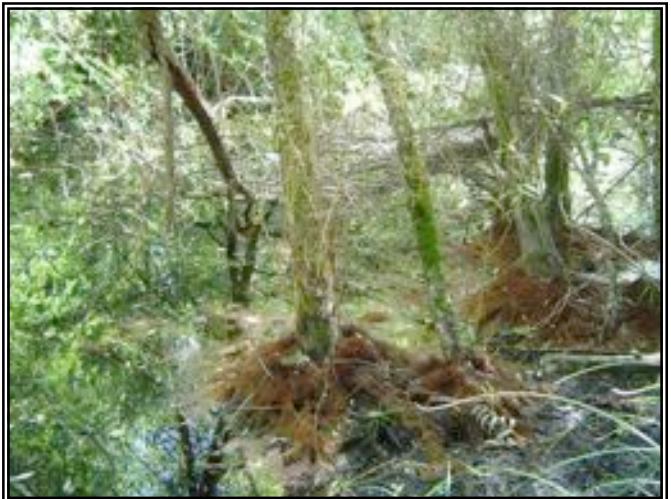
**16.** Golden willow root mats and suckers

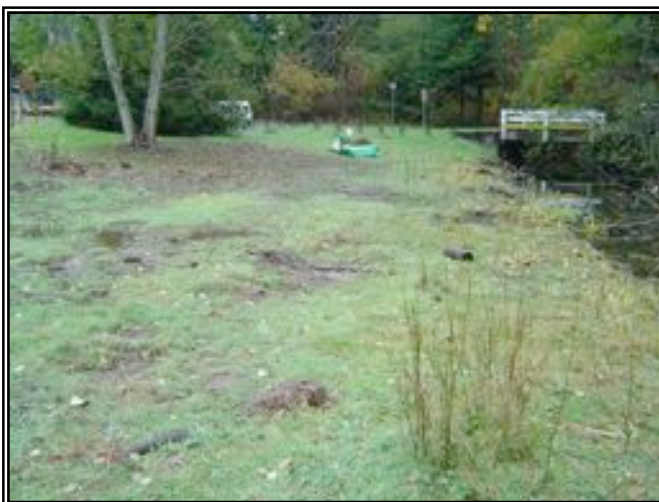
**17.** 2 Nov – Native cuttings planting

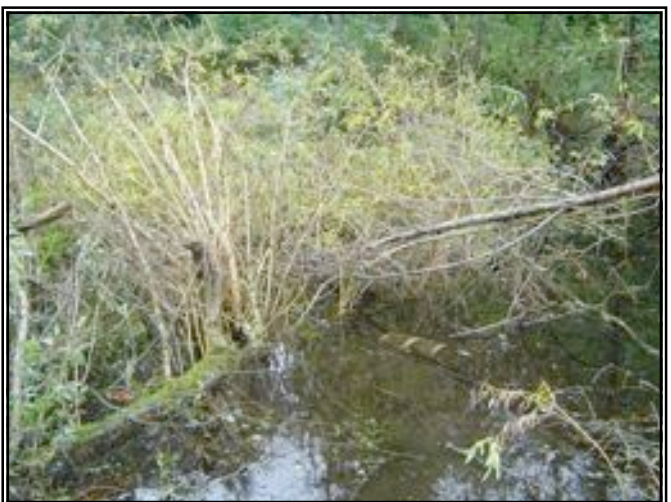
**18.** Golden willow in-stream logs and suckers

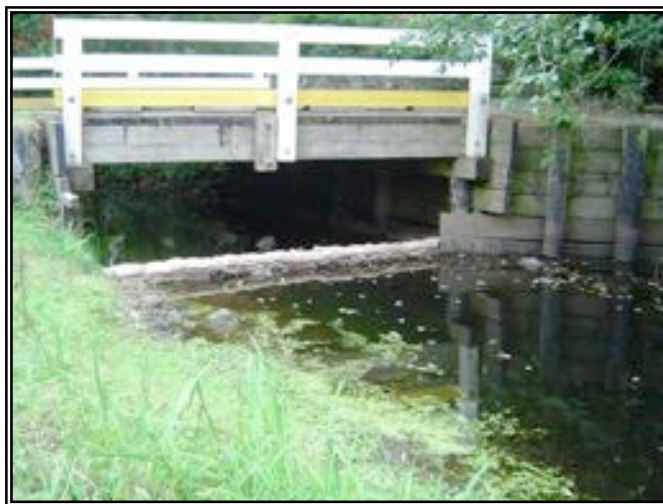
**19. BMPs – Downstream sandbag dam**

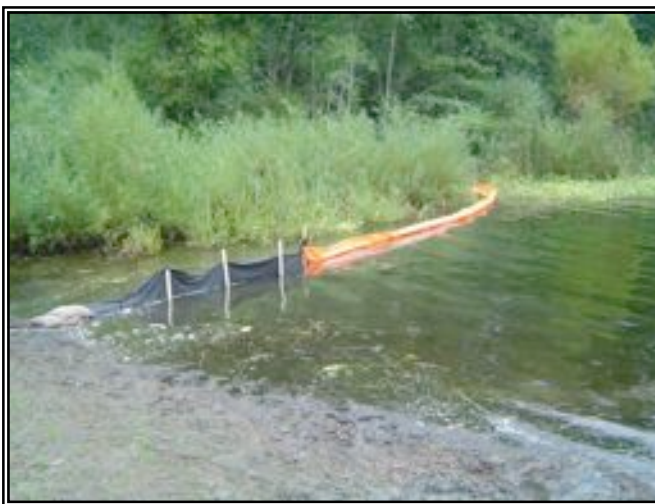
**20. BMPs – Upstream silt curtain and sandbags**

The upstream silt curtain was removed on September 30, 2010, after allowing a week for any remaining suspended sediment to settle. The downstream dam and remaining upstream sandbags were removed on October 5<sup>th</sup>, after receiving permission from MoE to spread the 5 mm stone contents of the bags in-situ, as an amendment to the degraded stream substrate (K. Telfer, pers. comm. Oct 2010; Photo 27).

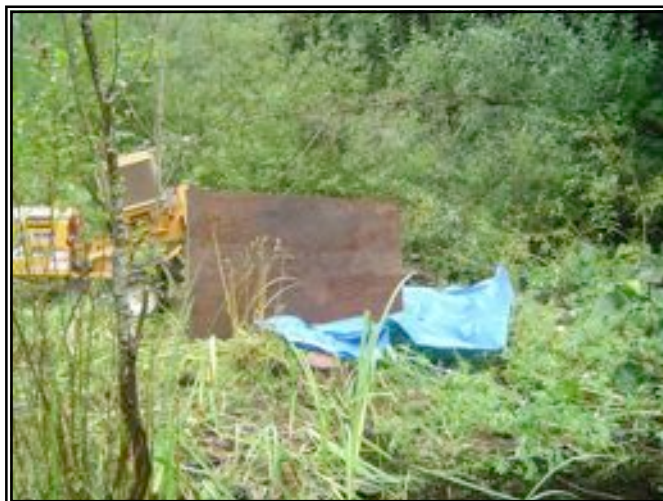
**21. BMPs – Stump grinding at water's edge**

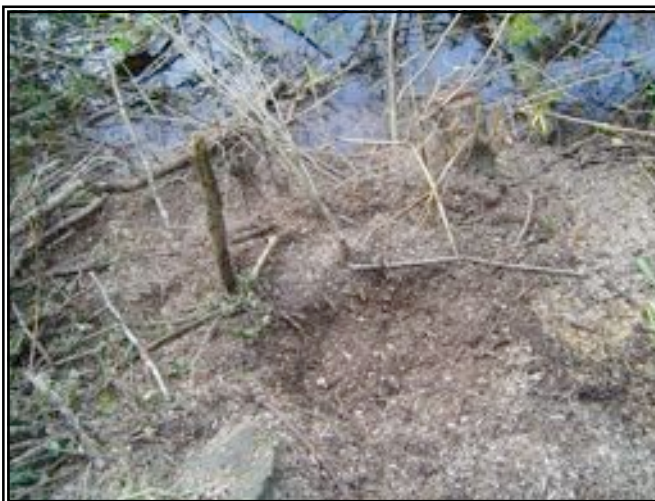
**22. BMPs – Stump grinding without tarps**

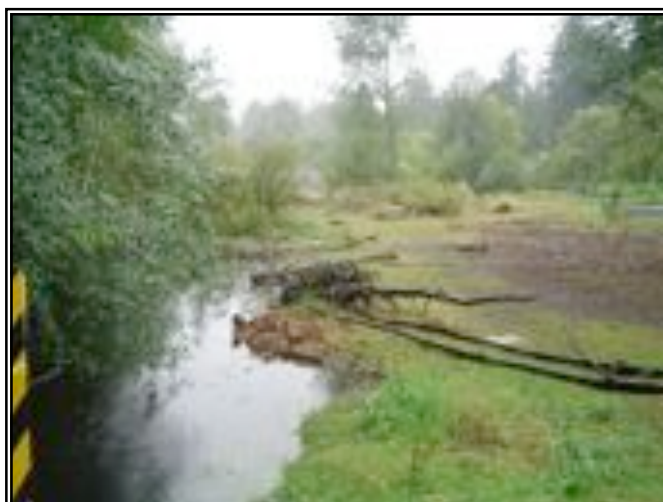
Tree removal work was halted on the following day, September 20<sup>th</sup>, due to this heavy rain and saturated conditions. An additional work day was halted on September 24<sup>th</sup> due to heavy rain and saturated conditions, in addition to mis-communication with an excavator crew conducting the removal of the in-stream vegetation pile at the west side of the creek (Photos 23-24). The remainder of the removal work was completed by

**23. 23 Sept – End of day site condition**

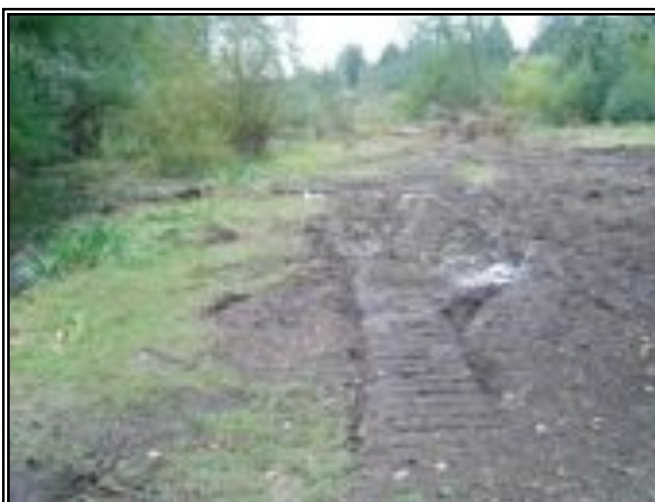
**24. 26 Sept – Excavator incursion into riparian area**

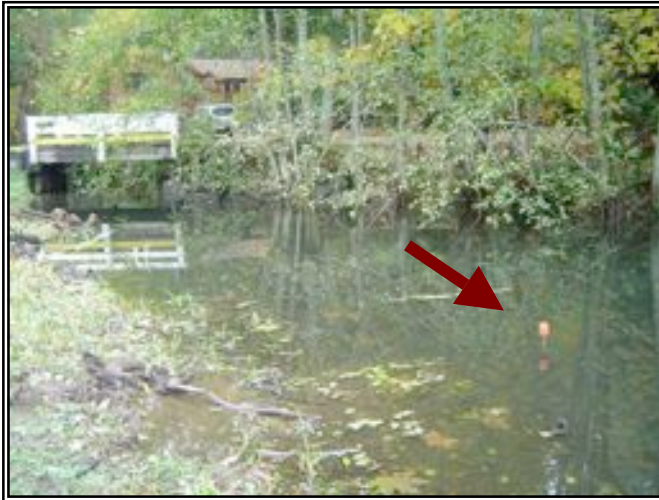
- Station S1 – 6 ft length of rebar solidly placed in stream bed, located off the west bank 30 m south of Goward Road bridge at edge of submerged willow root mats. Depth from top of rebar to sediment layer on 30 September 2010 measured 0.54 m (21 in.). Sediment layer here approximately 1 m (4 ft) deep.
- Station S2 – 10 ft length of rebar loosely in place in remaining willow trunk root structure, located off the east bank approximately 60 m south of Goward Road.

**25.** Sediment Monitoring Station S1 – red float at right

- Monitor rebar sediment stations twice annually to record the rehabilitation of the stream bed as accumulated sediment decays or is mobilized throughout the year.

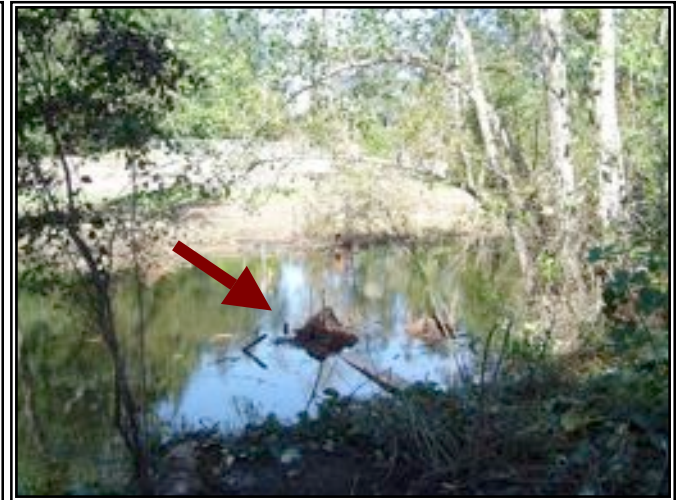
The depth of loose sediments in this location did not allow for the rebar to be firmly placed. A longer piece of rebar should be considered for this station. The bottom sediments in this location on September 30, 2010 were greater than 2.7 m (9 ft) in thickness [0.3 m (1 ft) from top of rebar to top of sediment layer]. For reference, the top of the rebar rested 0.3 m (1 ft) below the top of the willow stump adjacent.

**26.** Sediment Monitoring Station S2 – red float at centre

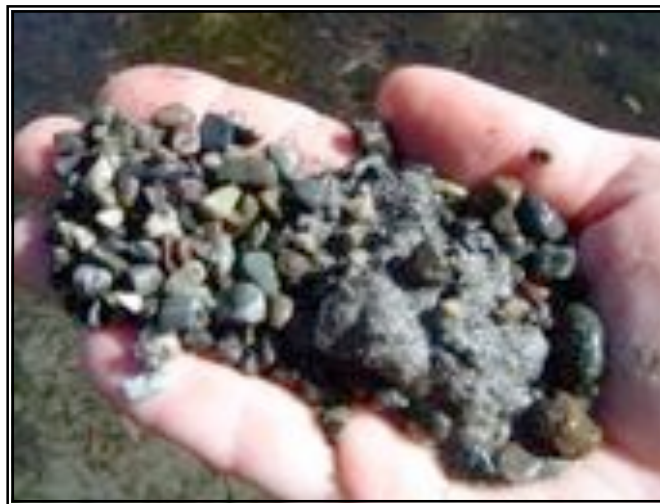
**27.** 5 mm sandbag stone (left); site substrate (right)
